**REFURBISHMENT AND DEMOLITION SURVEY
ASBESTOS SURVEY REPORT**

Survey Date: 27th January 2015
Site Name: Atlanta Building Clacton on Sea
Report Type: Asbestos Survey – Management
Issuing Office: 3a/b Morses Lane, Brightlingsea, Colchester, CO7 0SF

Report Number AAS 1015

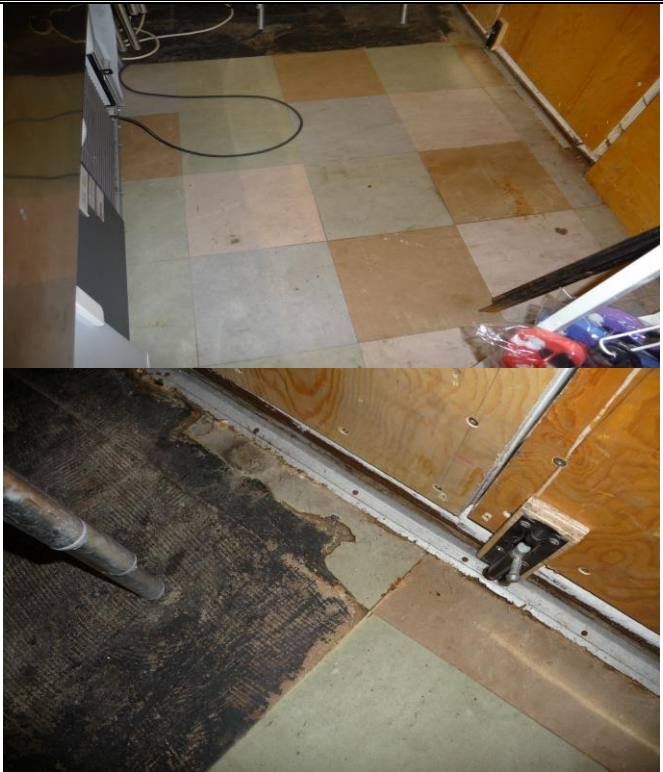
| MATERIAL ASSESSMENT REPORT:AAS 1015 | | | |
|--|---|---|---|
| Sample Date: | 28/01/2015 | Damage/Deterioration: | Poor |
| Description: | Multi-coloured floor tiles | | |
| COMMENTS: | <p>Samples were taken from the floor tiles to see if the sample taken contained asbestos in the sample. No Asbestos present in sample</p> | | |

| MATERIAL ASSESSMENT REPORT:AAS 1015 | | | |
|--|---|---|---|
| None | | | |

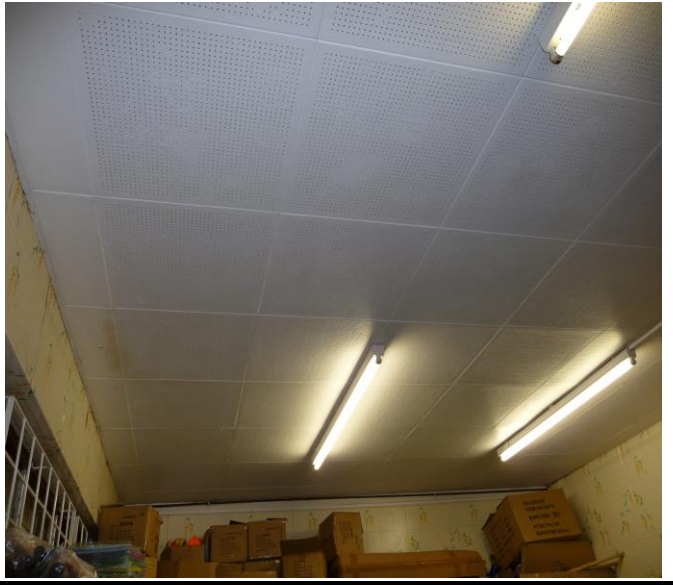
| MATERIAL ASSESSMENT REPORT:AAS 1015 | | | |
|--|--|---|---|
| Location: | Ice Cream Shop | | |

| MATERIAL ASSESSMENT REPORT:AAS 1015 | | | |
|--|--|---|---|
| Sample Date: | 28/01/2015 | Damage/Deterioration: | Good |
| Identification: | Ceiling tiles | | |

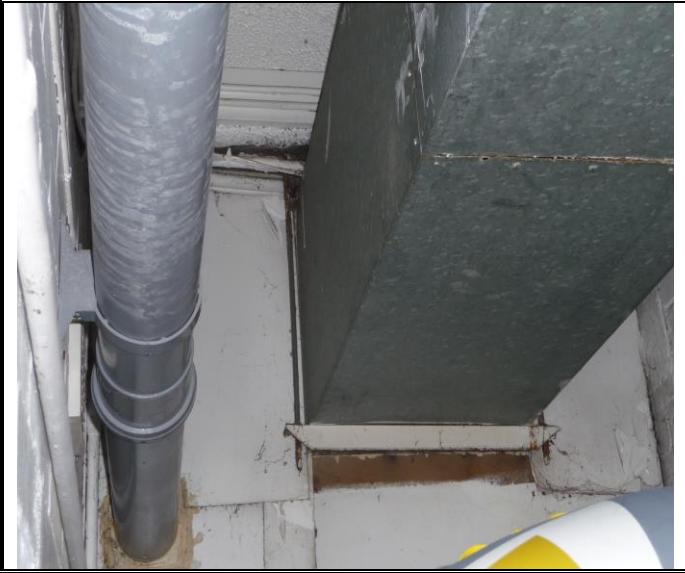
| MATERIAL ASSESSMENT REPORT:AAS 1015 | | | |
|--|---|---|---|
| Location: | Ice Cream shop | | |

| MATERIAL ASSESSMENT REPORT:AAS 1015 | | | |
|--|---|---|---|
| Sample Date: | 28/01/2015 | Damage/Deterioration: | Good |
| Identification: | Back entrances walk way | | |

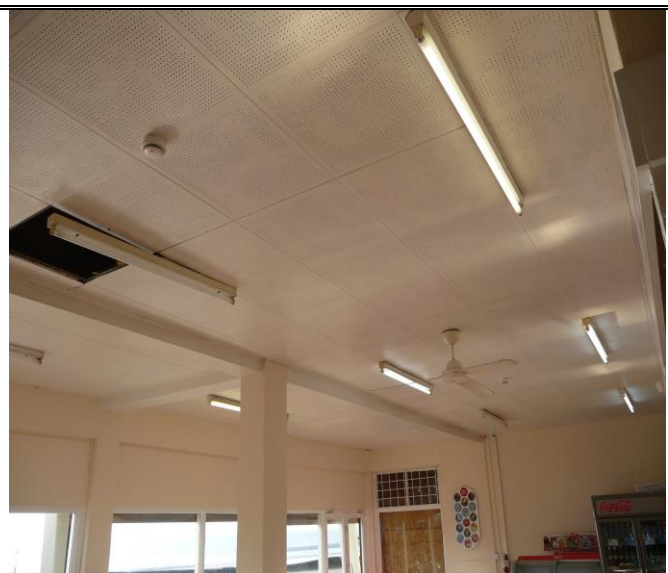
| MATERIAL ASSESSMENT REPORT:AAS 1015 | | | |
|--|---|---|---|
| Location: | The cafe | | |

| MATERIAL ASSESSMENT REPORT:AAS 1015 | | | |
|--|---|---|---|
| Sample Date: | 28/01/2015 | Damage/Deterioration: | Good |
| Identification: | Ceiling tiles | | |

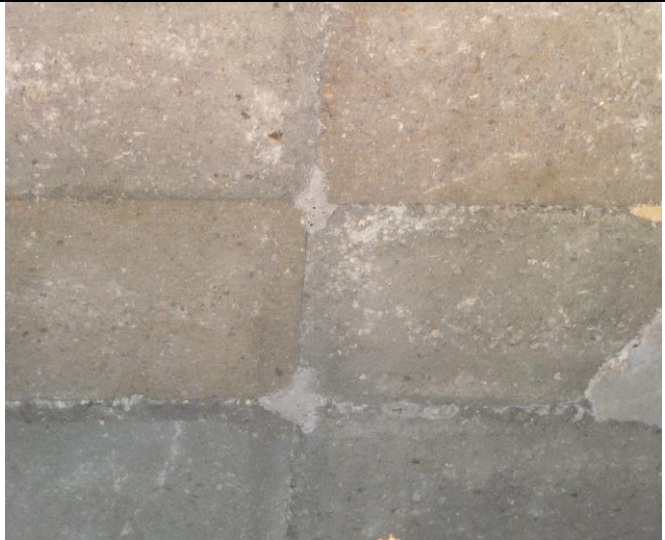
| MATERIAL ASSESSMENT REPORT:AAS 1015 | | | |
|--|---|---|---|
| Location: | The cafe | | |

| MATERIAL ASSESSMENT REPORT:AAS 1015 | | | |
|--|---|---|---|
| Sample Date: | 28/01/2015 | Damage/Deterioration: | Good |
| Identification: | Ceiling | | |

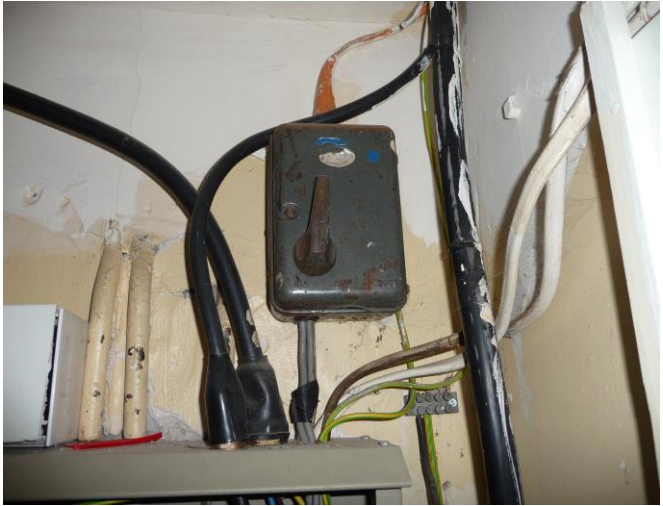
| MATERIAL ASSESSMENT REPORT:AAS 1015 | | | |
|---|--|---|---|
| Location: | The cafe | | |

| MATERIAL ASSESSMENT REPORT:AAS 1015 | | | |
|---|--|---|---|
| Sample Date: | 28/01/2015 | Damage/Deterioration: | Unknown |
| Surveyor: | Brian Toff | Asbestos Type: | Poss chrysotile |
| Identification: | Fuse Box | | |

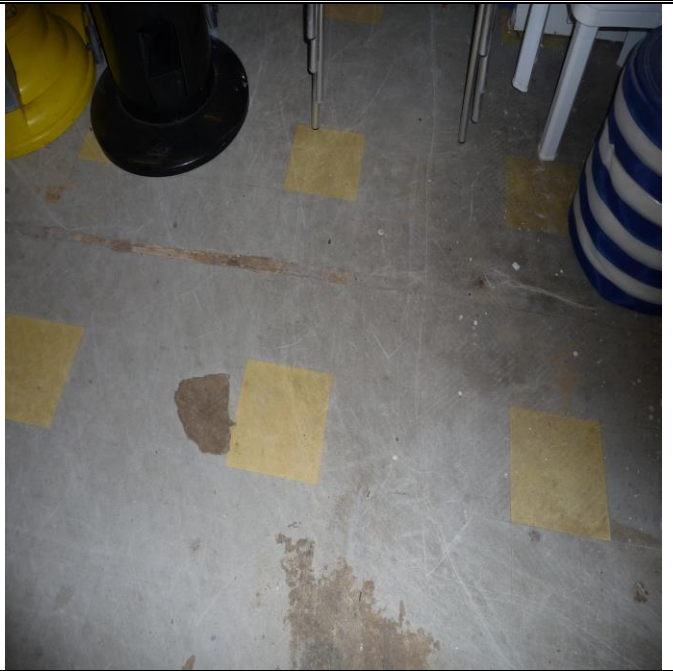
| MATERIAL ASSESSMENT REPORT:AAS 1015 | | | |
|--|--|---|---|
| Location: | Deckchair Shop | | |

| MATERIAL ASSESSMENT REPORT:AAS 1015 | | | |
|--|--|---|---|
| Sample Date: | 28/01/2015 | Damage/Deterioration: | Poor |
| Identification: | Floor Tiles | | |

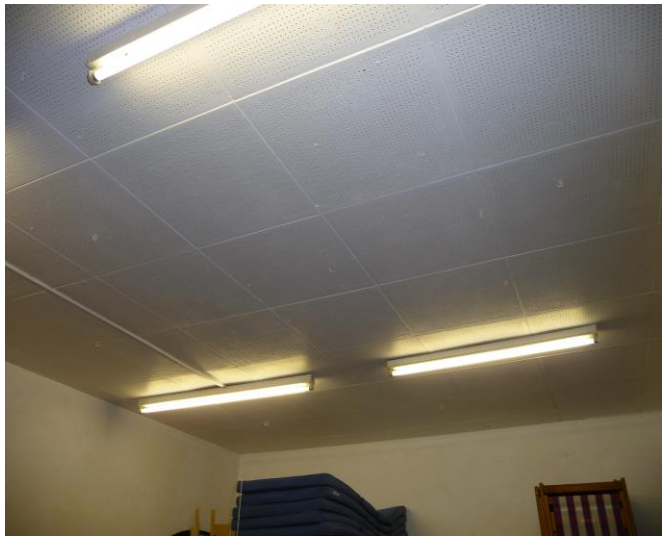
| MATERIAL ASSESSMENT REPORT:AAS 1015 | | | |
|--|---|---|---|
| Description: | Painted false ceiling tiles | | |
| COMMENTS: | Samples were mastered from sample AR2/2. No asbestos present in sample. | | |

| MATERIAL ASSESSMENT REPORT:AAS 1015 | | | |
|--|---|---|---|
| None | | | |

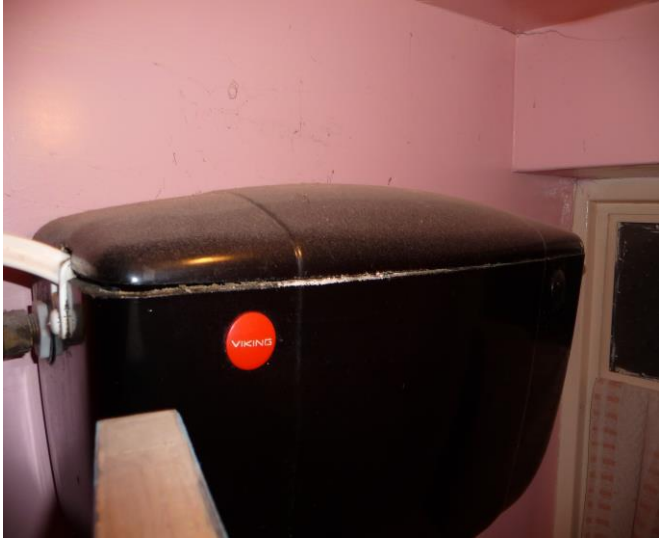
| MATERIAL ASSESSMENT REPORT:AAS 1015 | | | |
|--|---|---|---|
| <p align="center">SAMPLE INFORMATION</p> <p>Sample Ref: AR9</p> <p>Sample Date: 28/01/2015</p> <p>Surveyor: Brian Toff</p> <p>Building: Atlanta Building</p> <p>Location: The deckchair shop</p> <p>Floor: Ground floor</p> <p>Identification: Toilet System</p> <p>Position: Toilet wall</p> <p>Description: Poss asbestos toilet system</p> <p>COMMENTS: No samples were taken from the water system, toilets still in use poss asbestos until samples during a refurbishment asbestos survey</p> | | <p align="center">RISK ASSESSMENT</p> <p>Product: Toilet System</p> <p>Damage/Deterioration: Good</p> <p>Asbestos Type: Poss. Amosite</p> <p>Measurement 1 2m</p> | |

| MATERIAL ASSESSMENT REPORT:AAS 1015 | | | |
|--|---|---|---|
| Manage | | | |

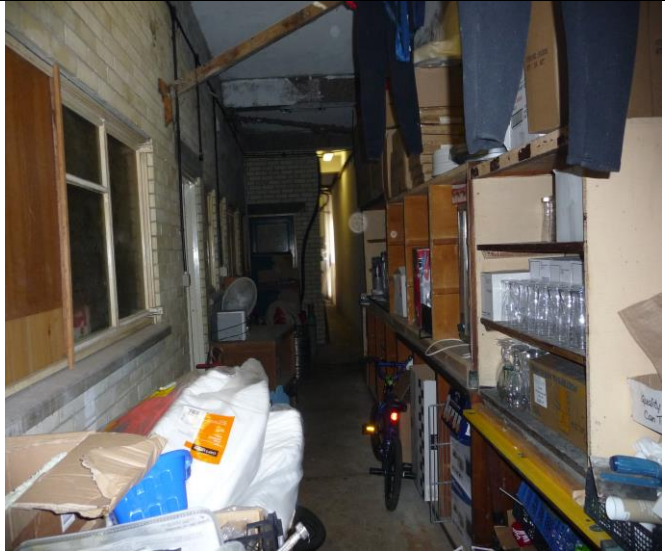
| MATERIAL ASSESSMENT REPORT:AAS 1015 | | | |
|--|--|---|---|
| Location: | Back walk way to all shops | | |

| MATERIAL ASSESSMENT REPORT:AAS 1015 | | | |
|--|--|---|---|
| Identification: | Brick and concrete | | |
| Description: | No asbestos found on the management survey | | |

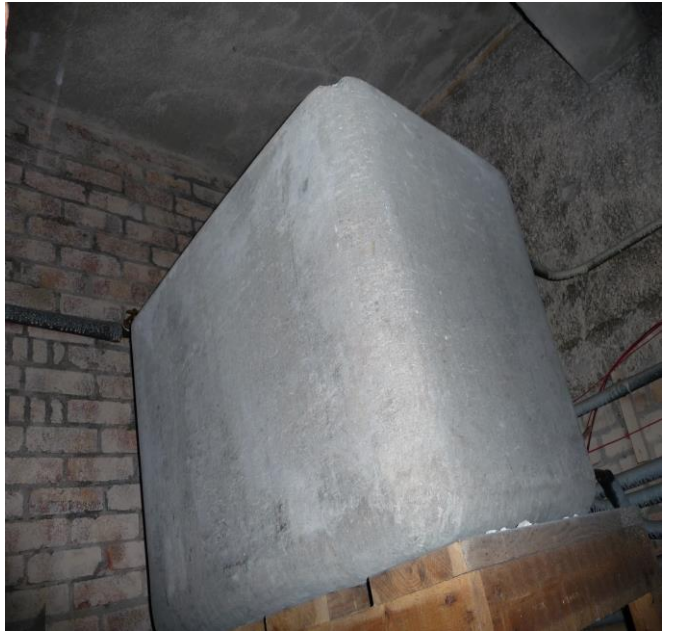
| MATERIAL ASSESSMENT REPORT:AAS 1015 | | | |
|--|---|---|---|
| <p align="center">SAMPLE INFORMATION</p> <p>Sample Ref: AR11/3</p> <p>Sample Date: 28/01/2015</p> <p>Surveyor: Brian Toff</p> <p>Building: Atlanta Building</p> <p>Location: Stage area</p> <p>Floor: First Floor</p> <p>Identification: Old water tank</p> <p>Position: Disused tank room to side of stage</p> <p>Description: A/C water tank</p> <p>COMMENTS: Samples were taken from the water tank to see if the sample taken contained asbestos. Asbestos present in sample remove prior to carrying out refurbishment works</p> | | <p align="center">RISK ASSESSMENT</p> <p>Product: A/C Water Tank</p> <p>Damage/Deterioration: Poor</p> <p>Asbestos Type: Chrysotile/Crocidolite</p> <p>Measurement 2 2m</p> | |

| MATERIAL ASSESSMENT REPORT:AAS 1015 | | | |
|--|---|---|---|
| Remove prior to refurbishment works | Prior to refurbishment works | | |

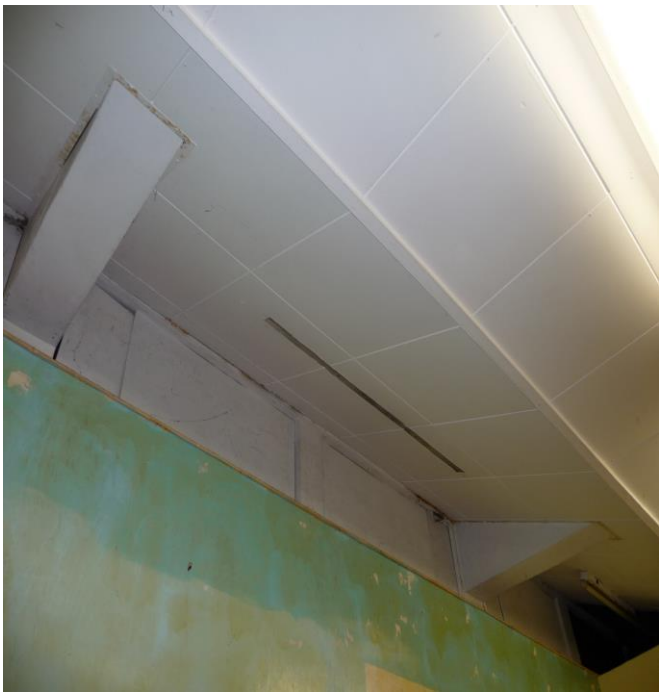
| MATERIAL ASSESSMENT REPORT:AAS 1015 | | | |
|---|---|---|---|
| <p style="text-align: center;">SAMPLE INFORMATION</p> <p>Sample Ref: AR12/4</p> <p>Sample Date: 28/01/2015</p> <p>Surveyor: Brian Toff</p> <p>Building: Atlanta Building</p> <p>Location: Stage area</p> <p>Floor: First Floor</p> <p>Identification: AIB Tiles</p> <p>Position: False ceiling tiles</p> <p>Description: Asbestos insulation board</p> <p>COMMENTS: Samples were taken from the ceiling tiles to see if the sample taken contained asbestos. Asbestos present in sample remove prior to carrying out refurbishment works, no works should be carried out around these areas.</p> | | <p style="text-align: center;">RISK ASSESSMENT</p> <p>Product: AIB Ceiling Tiles</p> <p>Damage/Deterioration: Fair (Painted)</p> <p>Asbestos Type: Amosite / Chrysotile</p> <p>Measurement 60 2m</p> | |

| MATERIAL ASSESSMENT REPORT:AAS 1015 | | | |
|---|---|---|---|
| Remove prior to refurbishment works | Prior to refurbishment works | | |

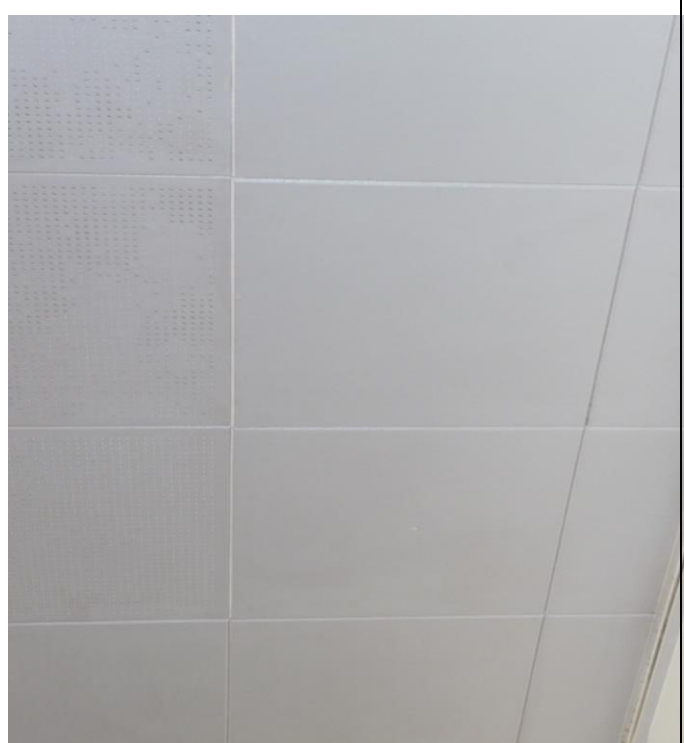
| MATERIAL ASSESSMENT REPORT:AAS 1015 | | | |
|--|---|---|---|
| Location: | Record and Cd stores | | |

| MATERIAL ASSESSMENT REPORT:AAS 1015 | | | |
|--|---|---|---|
| Sample Date: | 28/01/2015 | Damage/Deterioration: | Fair (Painted) |
| Surveyor: | Brian Toff | Asbestos Type: | Amosite / Chrysotile |
| Identification: | AIB Tiles | | |
| COMMENTS: | <p>Samples were mastered from sample AR12/4. Asbestos present in sample, remove prior to carrying out refurbishment works, no works should be carried out around these areas or to the ceilings them self's. It was noted that in some of the areas new light fitting have been fitted to the ceiling, any further works should be stopped and the ceiling removed as a priority. By a licenced asbestos contractor</p> | | |

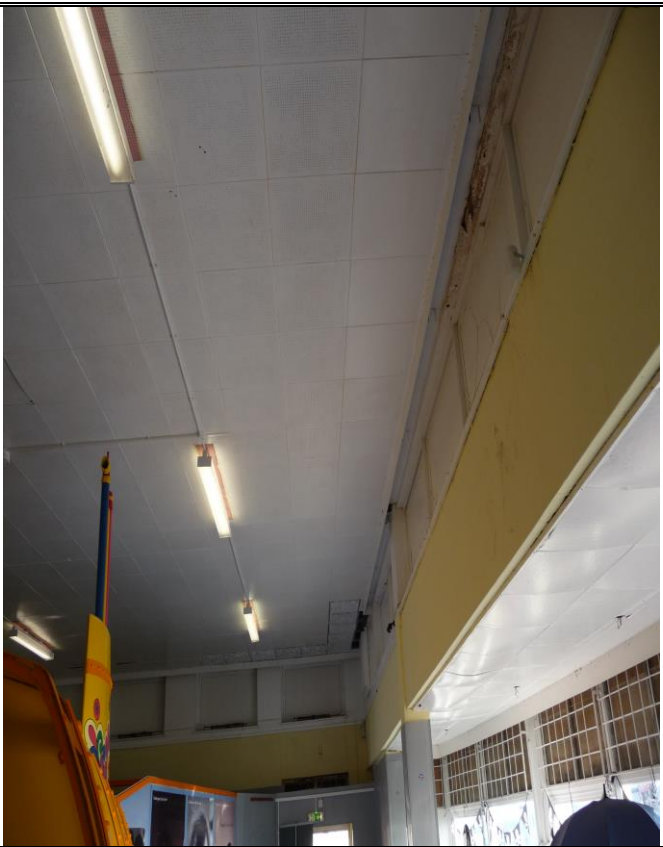
| MATERIAL ASSESSMENT REPORT:AAS 1015 | | | |
|--|---|--|---|
| <p align="center">SAMPLE INFORMATION</p> <p>Sample Ref: AR16</p> <p>Sample Date: 28/01/2015</p> <p>Surveyor: Brian Toff</p> <p>Building: Atlanta Building</p> <p>Location: Main ceiling</p> <p>Floor: First Floor</p> <p>Identification: False ceiling tiles</p> <p>Position: Ceiling</p> <p>Description: Possible asbestos insulation tiles</p> <p>COMMENTS: No samples were taken from the main ceiling area to the first floor, the main hall ceilings was too high to inspect on the management survey , the ceiling tiles are not all matching, some of the tiles have been replaced over the years so we could not determine if asbestos was present or not, care should be taken when working near these areas until further inspections are carried out to determine if asbestos is present to the ceiling tiles</p> | | <p align="center">RISK ASSESSMENT</p> <p>Product: False Ceiling Tiles</p> <p>Damage/Deterioration: Fair (Painted)</p> <p>Asbestos Type: Poss. Amosite / Chrysotile</p> <p>Measurement Throughout main floor</p> | |

| MATERIAL ASSESSMENT REPORT:AAS 1015 | | | |
|--|---|--|---|
| Remove prior to refurbishment works | | | |
