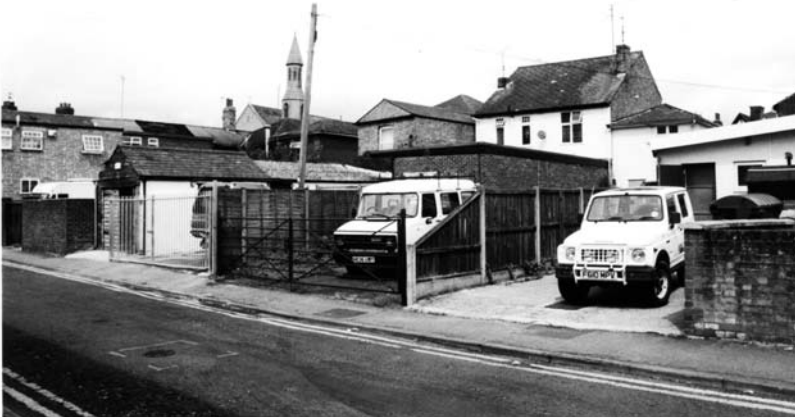
21. In contrast to the foregoing caption, rear yards of High Street properties in Thomas Street lack consistency and could be visually improved.

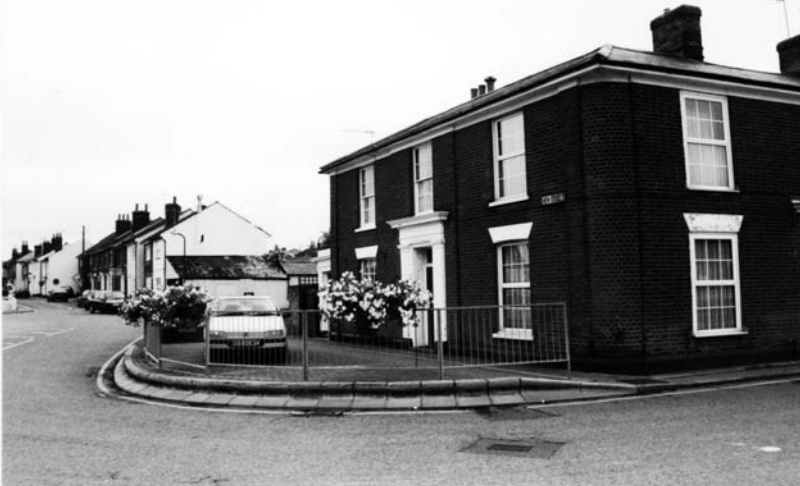
22. This attractive house dating from the second quarter of the 19th century is a significant feature at the foot of New Street where it meets Waterside and Colne Road. The small forecourt has been surfaced with unit paving, but the pedestrian barrier is insufficiently substantial in this context.

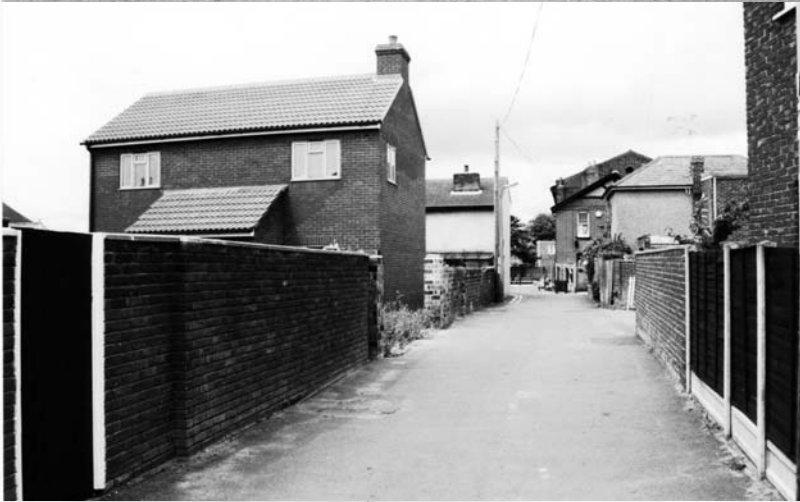
23. Recent housing developments have transformed Hall Cut but the carriageway itself is bland and uninteresting. With greater consideration also given to the storage requirements of the supermarket on the main road frontage, the comprehensive consideration of Hall Cut would be an enhancement of the Area as a whole.

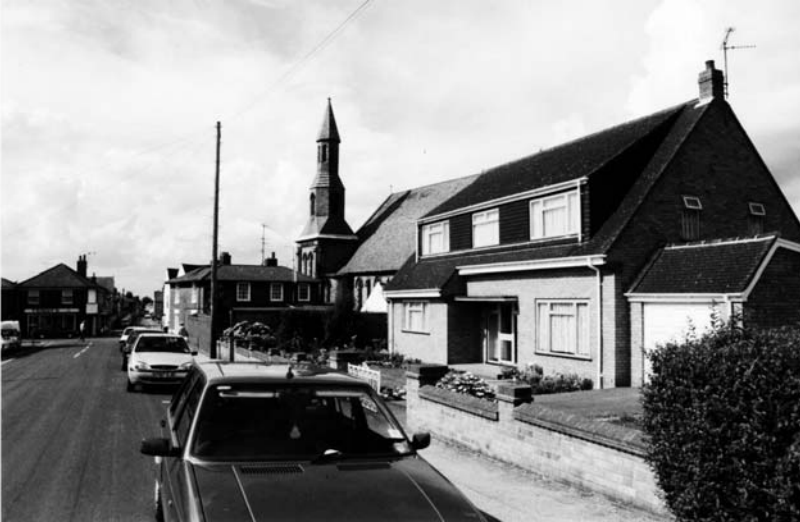
24. This house on Richard Avenue is on the edge of the Area and does not have a strong relationship with any other buildings or spaces of historic interest. Along with the church centre and the vicarage, it is recommended for exclusion from the Area.
