Brightlingsea Hall & All Saints Church Conservation Area

The Hall
Thoring

CONSERVATION AREA CHARACTER APPRAISALS

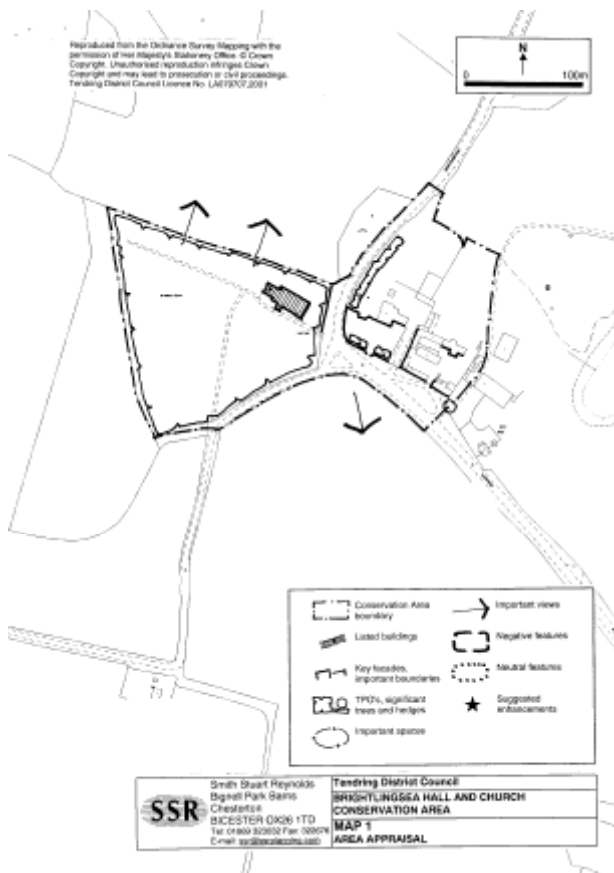
1. Church Road, All Saints Church and the road junction from the south east. The visual significance of the main road is clearly apparent in this view, as is the important mature planting to the frontage of the Hall on the right of the photograph.

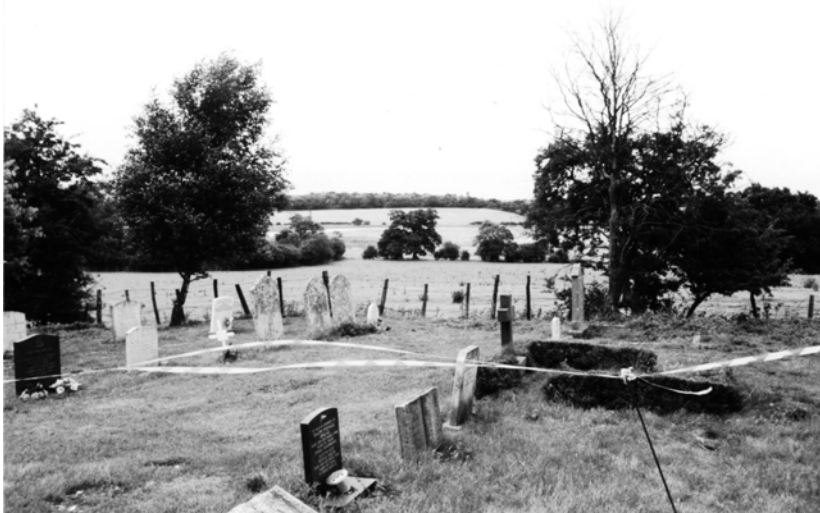
2. This view taken next to the west tower of the church is one of a sequence overlooking the Creek from this part of the churchyard. The extensive churchyard has many mature trees, and gains interest from the combination of formal and informal maintenance.

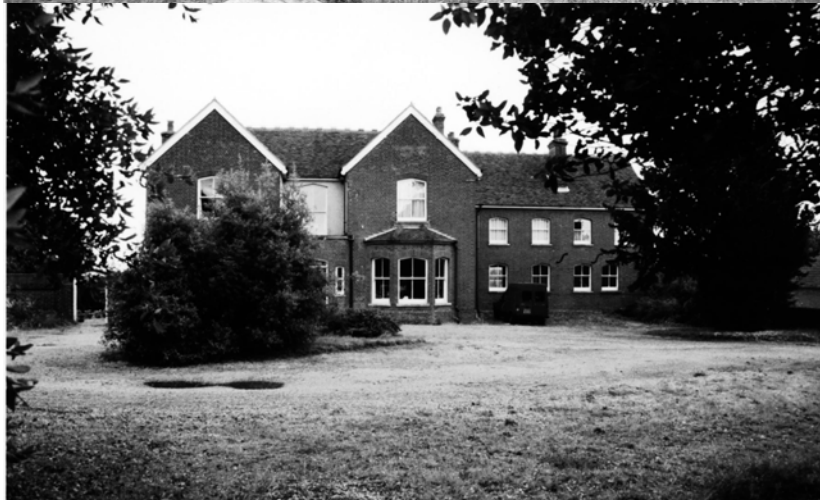
3. The front elevation to the Hall shows its simple detailing and the vestiges of its former designed setting.

The Hall is a plain building and as such is relatively dependent on the quality of its setting. It is clear from the surviving indications of drives and garden walls that this was originally of some scale and interest, though little maintenance appears to have been carried out for some considerable time. It is to be hoped that sufficient investment can be generated to provide the Hall with amore worthy setting.

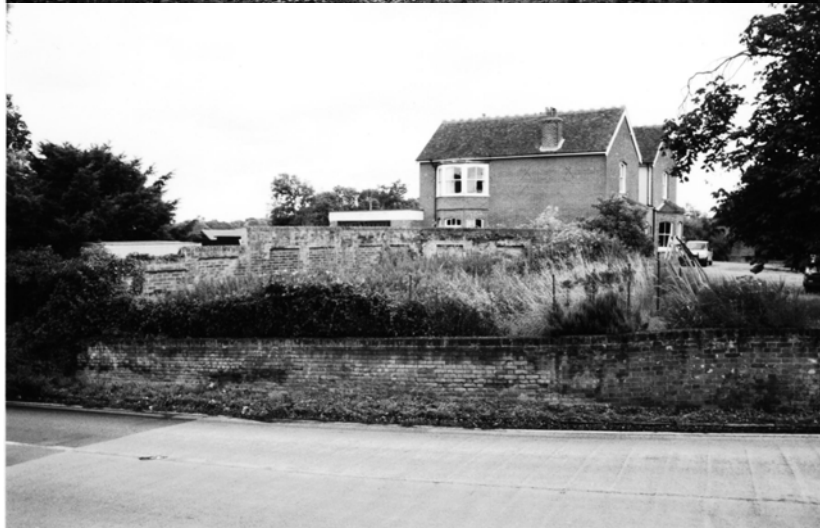
4. The Hall from the churchyard frontage to the west. The front boundary wall, incidental walling within its curtilage and the mature trees are all significant features which would be enhanced by greater maintenance.

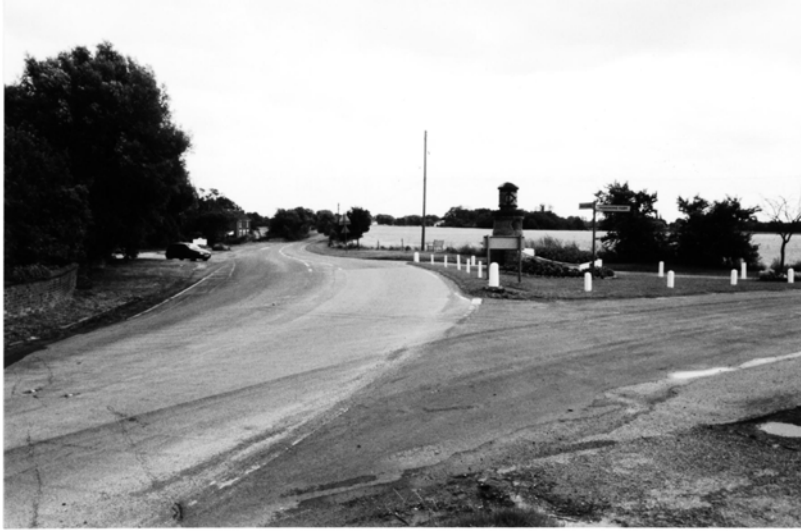
5. Church Road from the Lych gate, looking towards the town. Once again the road is dominant, reinforced by the relative amenity associated with the road junction.

Similarly, the triangular junction in front of the churchyard lych gate has relatively large expanses of tarmac and the churchyard frontage itself is rather haphazardly surfaced. This may have been due in part to the building works being carried on at the church at the time of survey, but is worth noting for remedial work in the future.

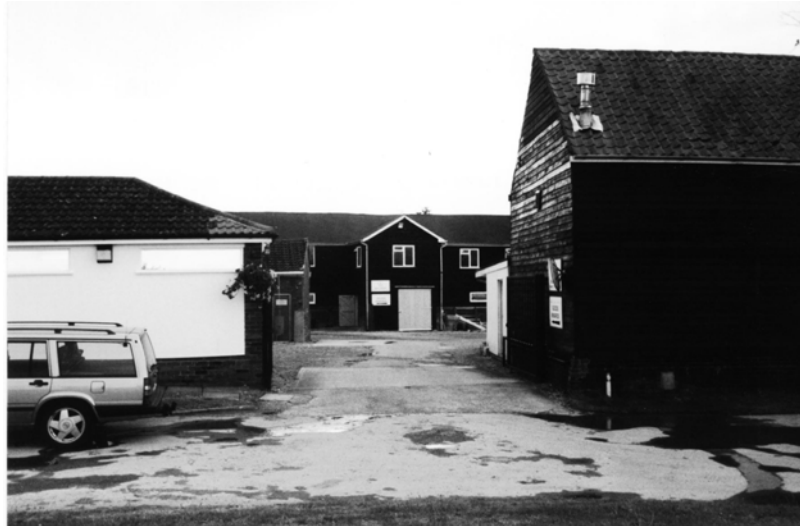
6. The entrance to the yard occupied by the buildings. Labelling. On the right and in the distance are the most significant structures on the site; their presence has historic significance and help to enclose the area. Investment in these buildings and their surroundings would be an enhancement of the Area as a whole.

This firm occupies a variety of buildings to the east of the Hall. In absolute terms, the ability of the current or any future occupier of the site to be able to invest more in buildings and their setting would be a visual enhancement of the Area. Such an investment would include the improvement of the larger, more significant structures, the replacement of the more temporary buildings, and the reconsideration of intervening spaces.

The courtyard spaces associated with the works are surfaced and patched in a variety of materials. The comments made above about the works buildings are equally relevant to the condition and appearance of the yards and other intervening spaces.
