Listed Buildings

# Technical Advice on Windows & Window Details

Tendring
District Council

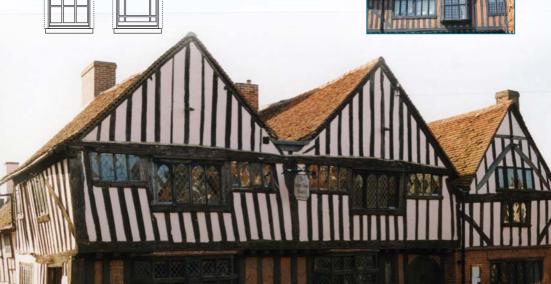
Right: 15th Century former farmhouse, The Moot Hall, Clacton with square leaded mullion and transom windows

- c). In the 17th Century the mullion and transom type of window was developed. Usually in oak with leaded light glazing it represents a transitional type towards more vertically oriented windows. The basic pattern was still in use in the nineteenth century but in painted softwood with nine large panes of glass.

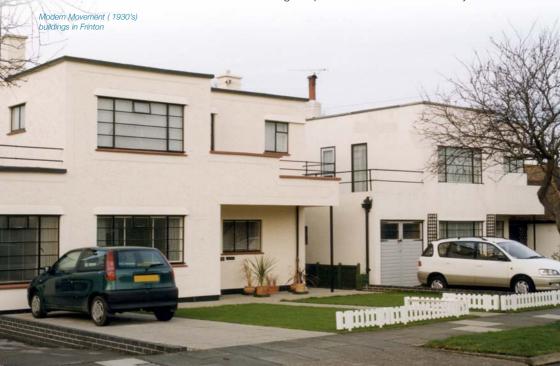
#### Glazing Bars

Source	
Hampton Court	Cupola of Eagle
	House, Mitchem
Date	
1689-94	1705
Width	
40mm	30mm
Depth	
42mm	33mm

Source		
Berners	The Barons	Beford Square
London	Reigate	London
Date		
c1750	1721	1775-86
Width		
22mm	19mm	15mm
Depth		
44mm	32mm	40mm

Source	1
Typical Victorian	Typical modern
'lamb's tongue (repo)	double glazing bar
Width	
15mm	45mm
Depth	
35mm	64mm

The earliest glazing bars of both sash and casement windows were numerous and thick. On the inside they were moulded to deflect light and reduce glare. On the outside they were rebated to take the glass pane, held in place by putty as they are to this day.

Over the years the cross-sectional area of glazing bars gradually reduced, eventually reaching a point in the late 18th and early 19th Century when width was as little as 13mm (half an inch). As a result these narrow bars were often made of hardwood or even metal. At the same time the size of the glass panes increased considerably.
