The Essex Countryside  
HISTORIC BARNs  
A Planning Appraisal

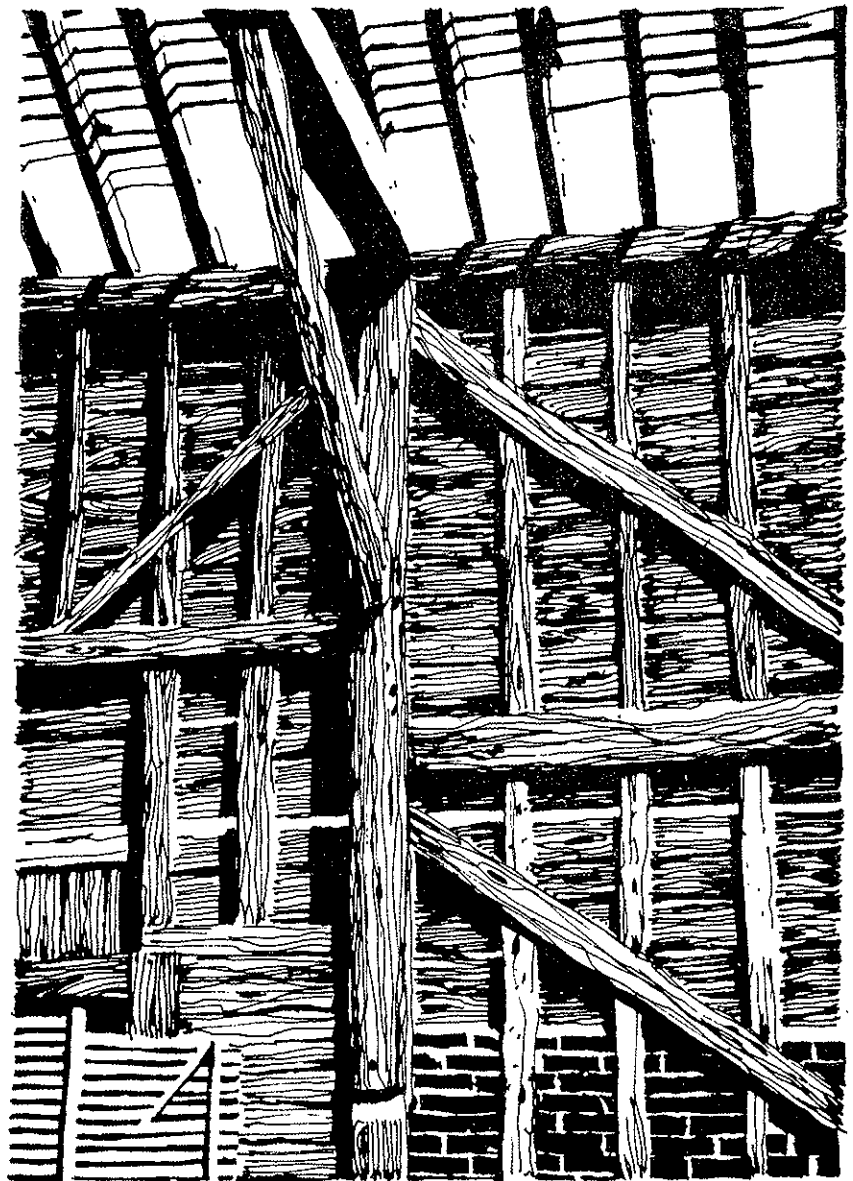
Fig. 16

Interior of 17th century barn showing main post and through braces – note absence of ‘jowls’.

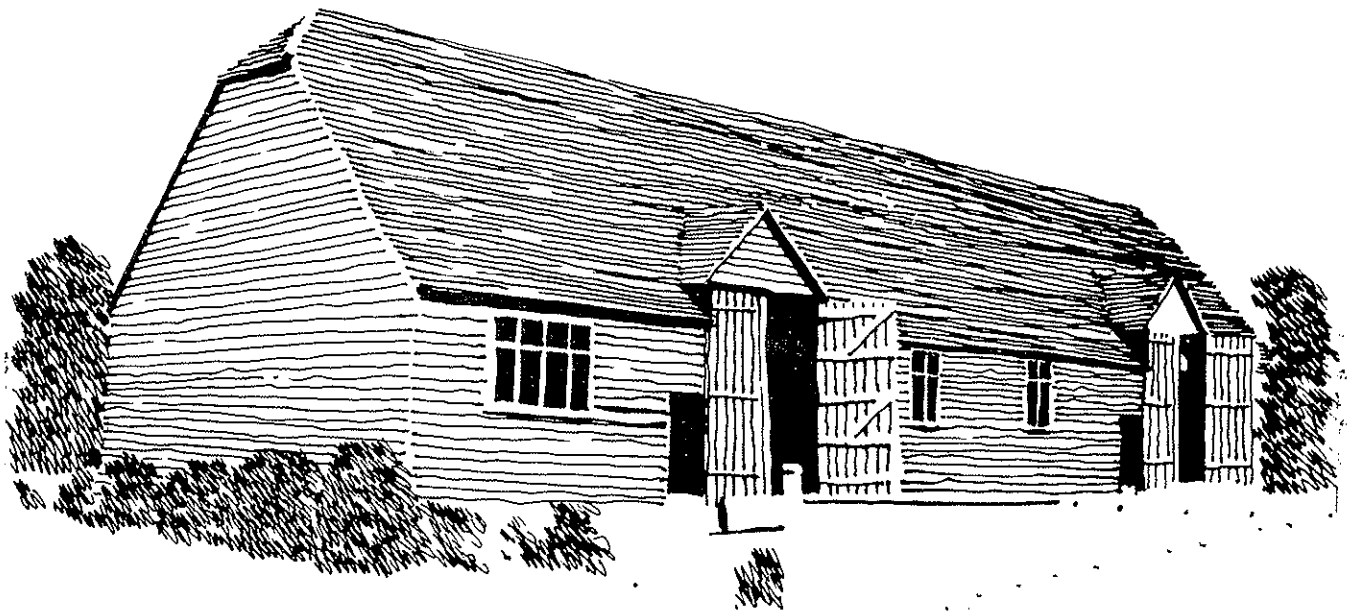
Fig. 26

Barn at Lordship Farm, Writtle, now in use as repair-workshop for agricultural machinery.
