Thorpe-Le-Soken Conservation Area Character Appraisal and Management Plan

Tendring
District Council

Date:
December 2021

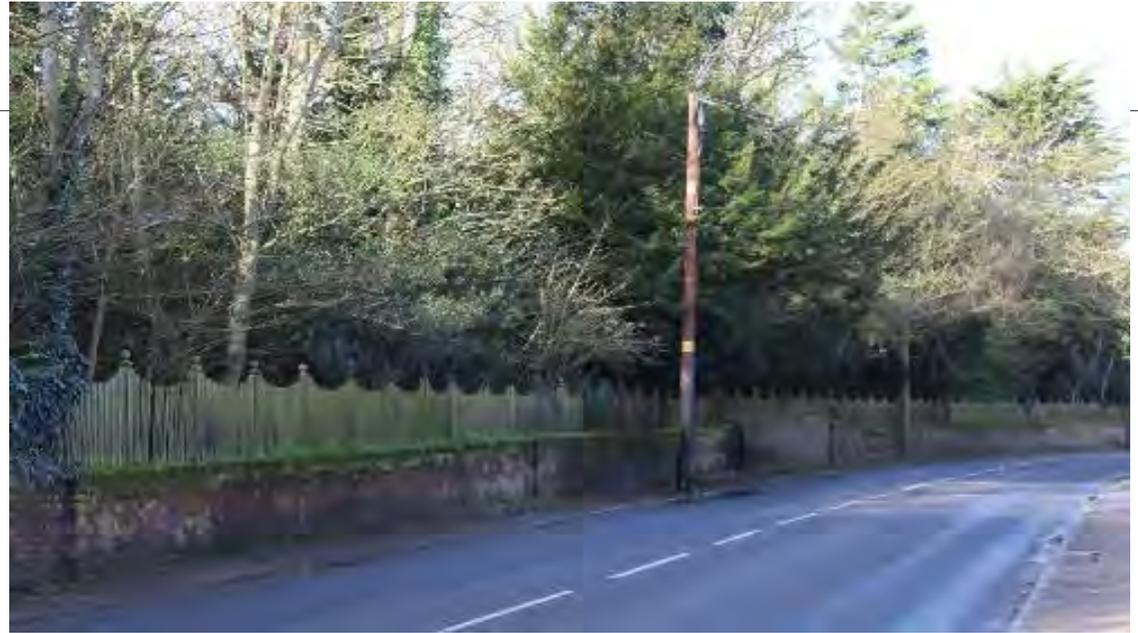
Many buildings along the High Street front directly onto the pavement edge but others have small front yards or parking areas. Red brick walls laid in Flemish bond are a common boundary treatment within this area which strengthens local character. Low metal railings painted black and timber picket fences are also common features within the street scene. The uniformity of detailing and materials of front boundary treatments throughout the area contributes to the area's character and significance. There are examples within the Conservation Area where brick wall boundaries have been removed to accommodate a front parking space and this has a detrimental impact on the area's character and appearance. The removal of boundary treatments to accommodate parking should be resisted as this removes an attribute of the Conservation Area that contributes to its significance.

Figure 49 Flemish bond brick-built boundaries contribute to the character of the Conservation Area

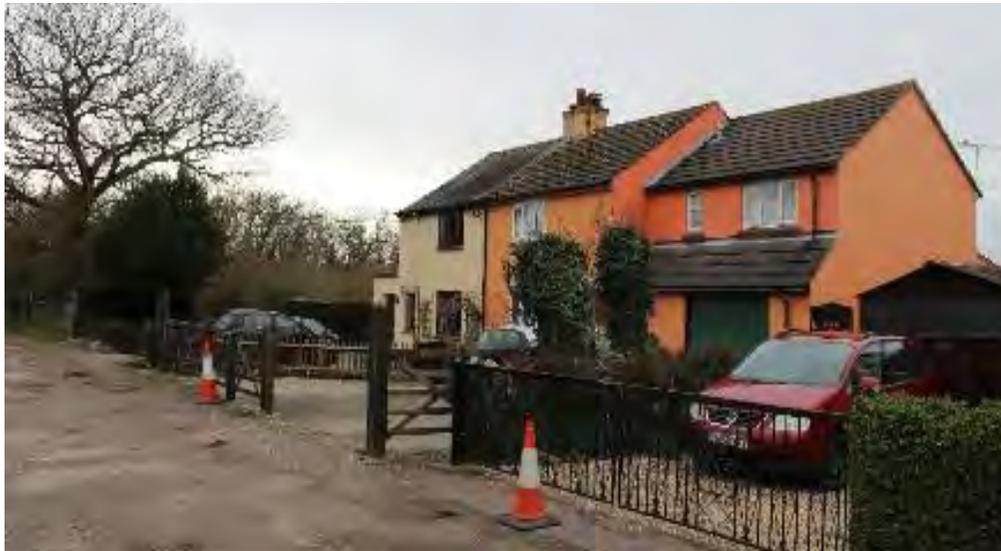
Some properties along Hall Lane have introduced substantial hardstanding and inappropriate boundary treatments which detract from the rural character of the secondary smaller lanes. Bollards and lighting along pathways are not complimentary of the character to the Registered Park and Garden. Hardstanding in the immediate area of the site previously occupied by the manor, is modern and detracts from the appearance of the Park and Garden and Character Area.

Figure 63 Examples of Boundary Treatments

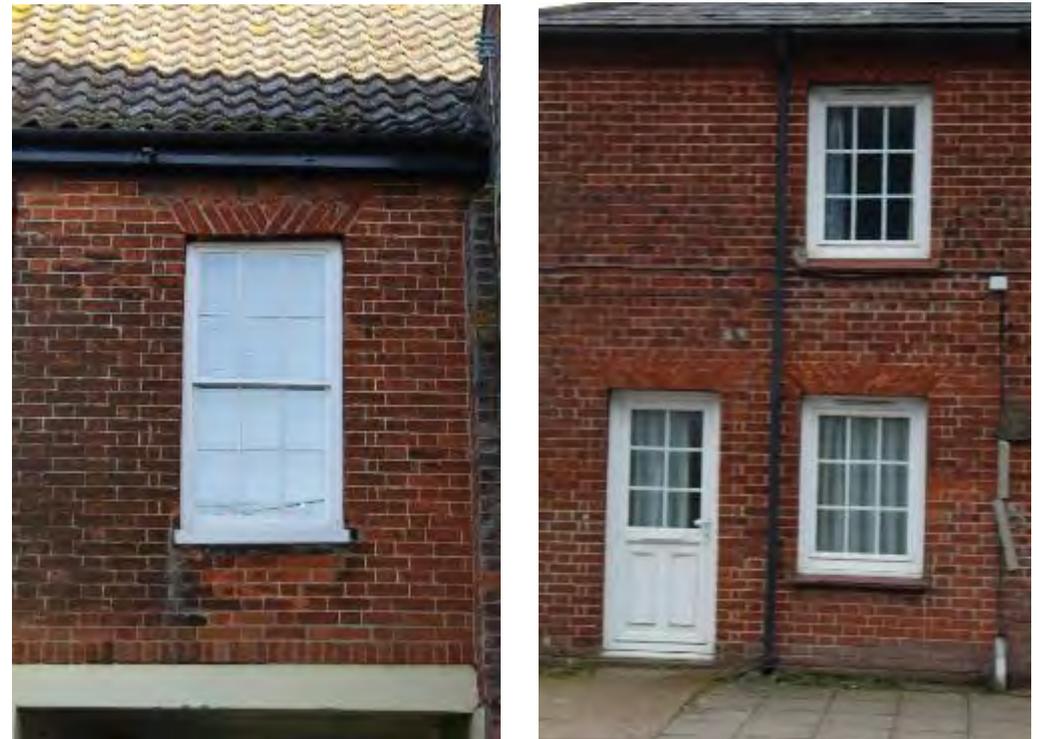
Figure 64 Examples of 'V' shaped red brick lintels

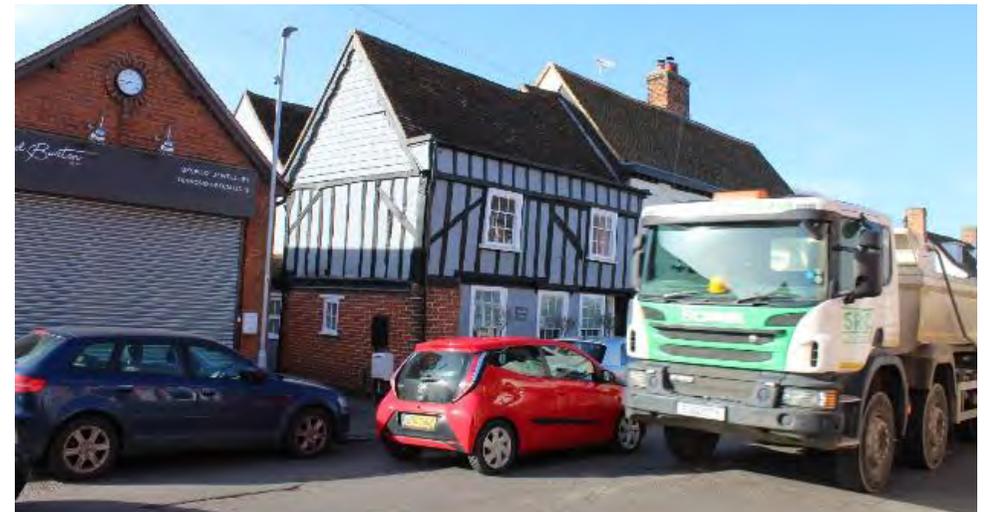
Along the High Street residential parking is limited to private driveways and on-street and pavement parking. The on-street parking detracts from the character and appearance of the Conservation Area. However, the addition of front driveways and removal of front gardens and boundary treatments along the High Street is inappropriate and the retention, or reinstatement, of street front boundaries should

Figure 70 Parking and heavy traffic on the High Street

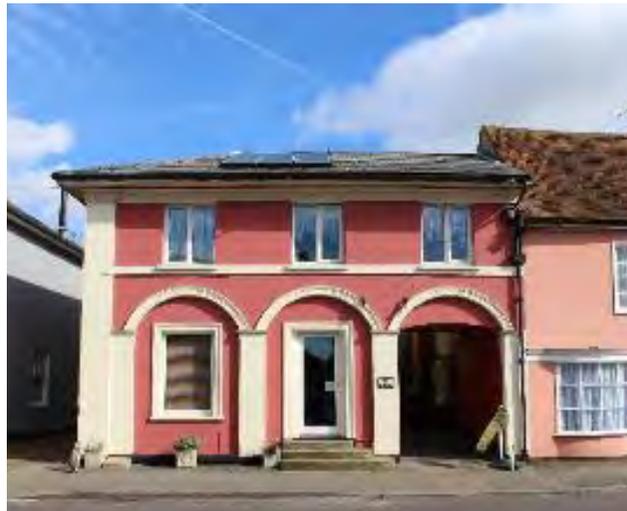
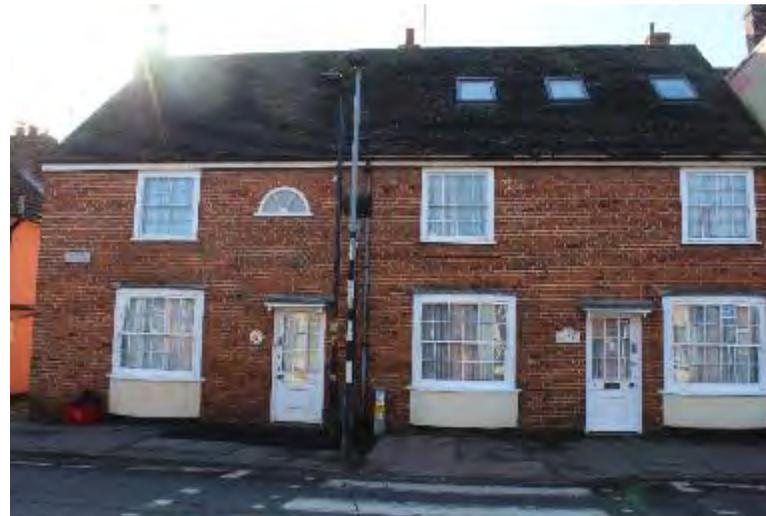
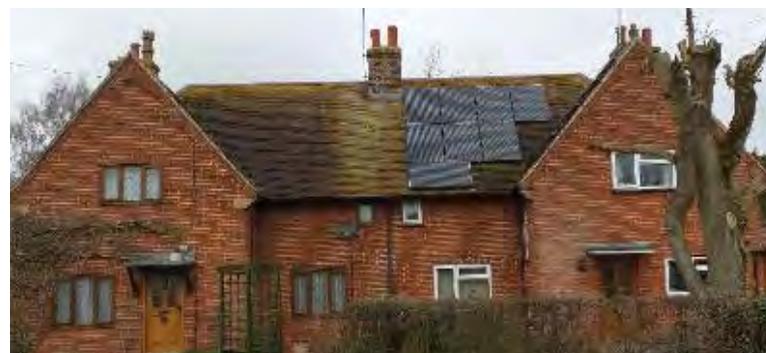
Figure 78 Examples of inappropriate Solar Panels and Rooflights

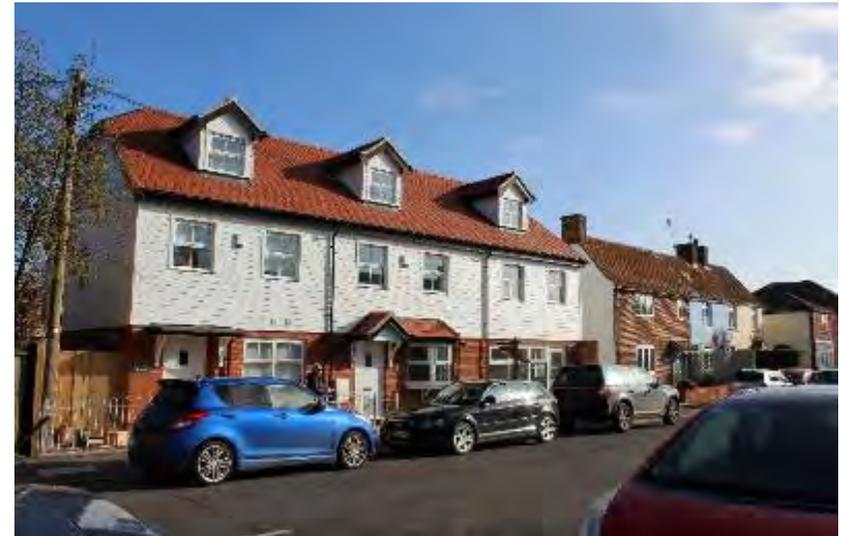
There are several cases within the Conservation Area where the plots of historic and listed buildings have been subdivided and developed with modern dwellings. Most notably at Hawthorns, a Grade II listed eighteenth century timber framed property (list entry no: 1112109). This is considered inappropriate, land plots and curtilages are a key indication of an area's development, by dividing historic plots it will dilute the special interest and have a detrimental impact on the context of the Conservation Area's development. Not only does the division of historic plots diminish the historical integrity of the property, it can also have an adverse effect on the setting of the individual heritage asset.

Figure 79 Modern development along the High Street

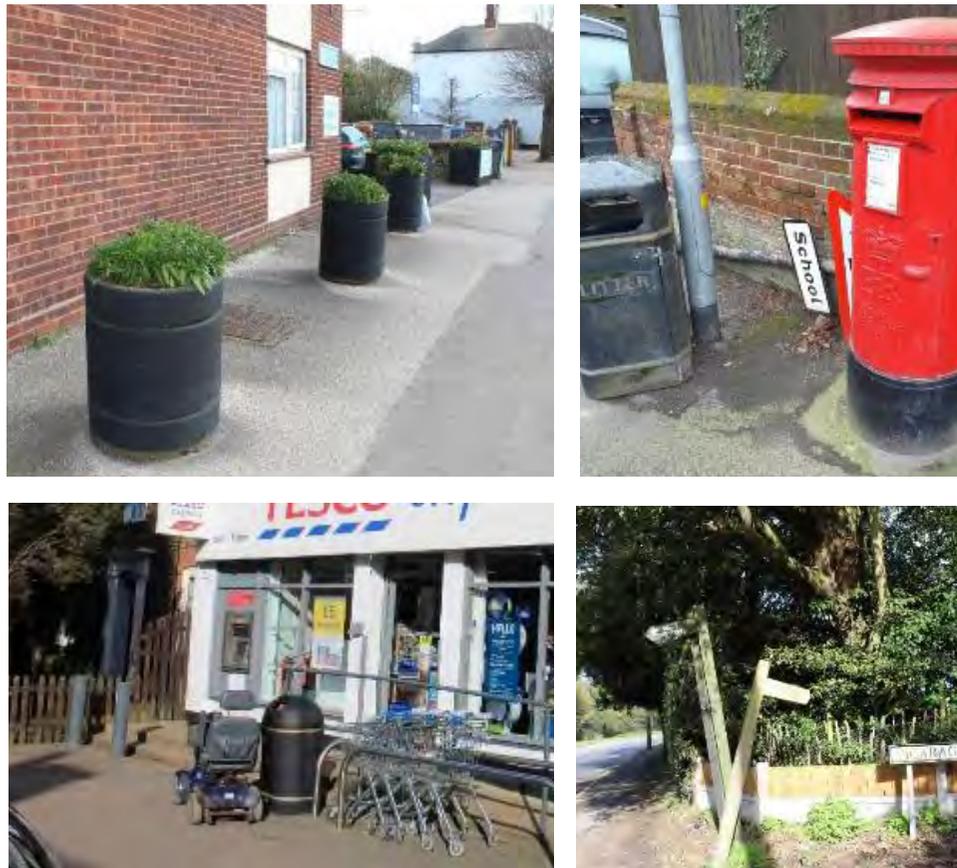
Figure 80 Opportunities to Enhance the Public Realm

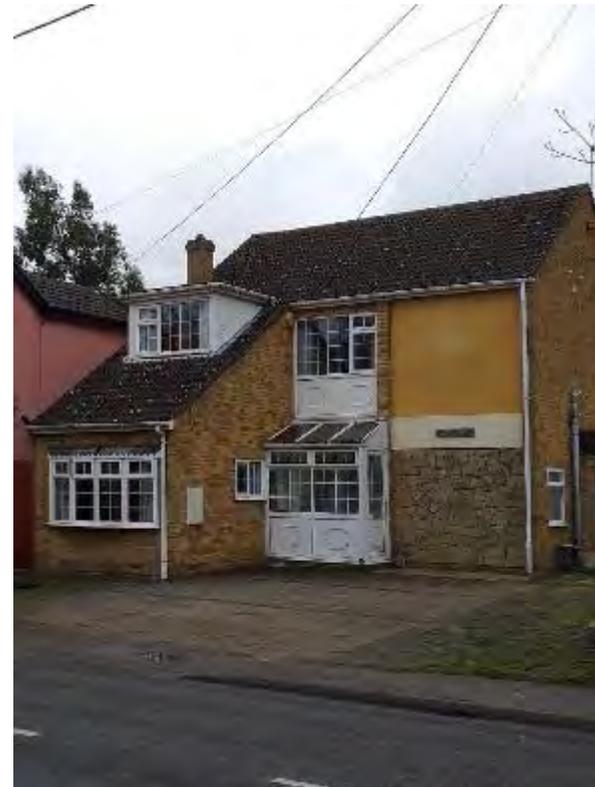
Figure 86 Modern development that does not reflect form, design or material of the Conservation Area

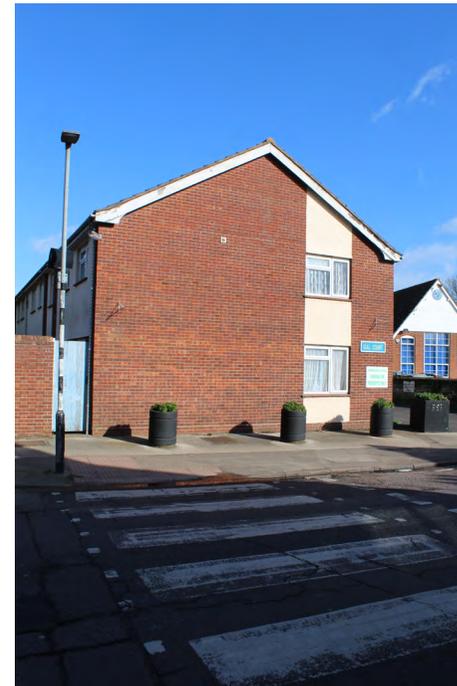
Figure 87 Unsympathetic street lighting

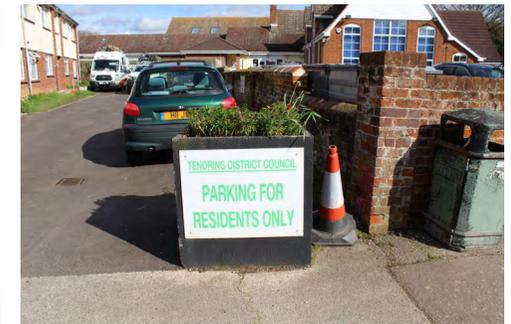
Figure 88 Signage and bin in poor condition

Poor maintenance leads to the deterioration of the fabric of the built environment and results in a loss of architectural details. Improved awareness of simple maintenance and repair would be conducive with the preservation of Thorpe-le-Soken's built heritage.
